**National Highway
Traffic Safety
Administration**

Case Vehicle (A): 1998 Toyota
Type: Camry LE, 4-door sedan
Driver: 73-year-old male
CDC: 12-FREE-2, 12-FLEE-1

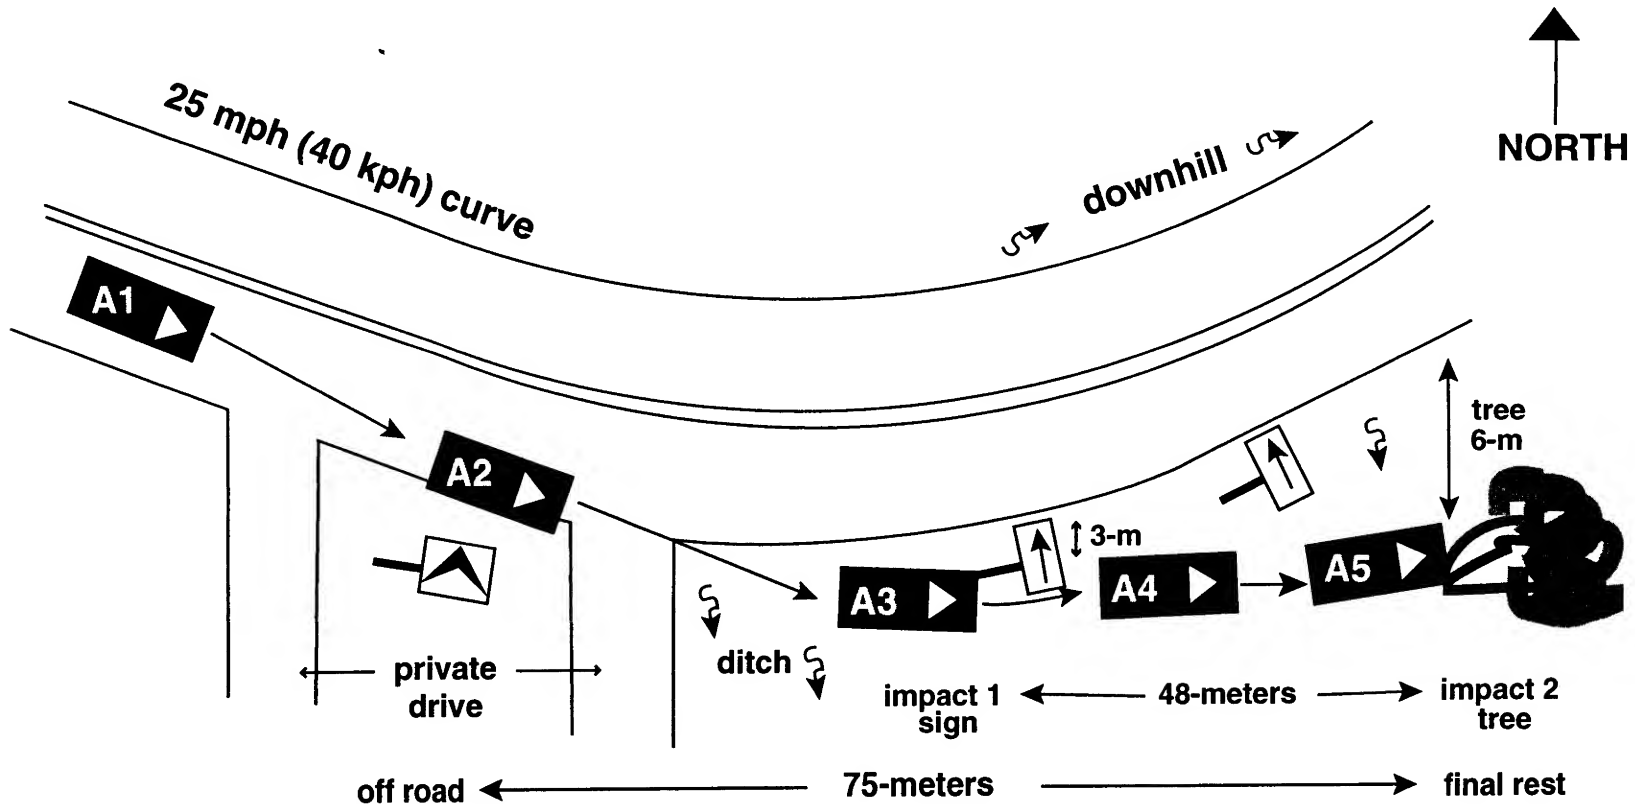
ACCIDENT SCHEMATIC

ACCIDENT DESCRIPTION: CASE VEHICLE (A) WAS TRAVELING
EAST AT AN UNKNOWN SPEED ON A TWO-LANE
ROAD IN A RURAL AREA. IT WAS SNOWING AND THE ROADS
WERE SNOW-COVERED AND ICY. THE DRIVER LOST CONTROL AND EXITED THE SOUTH EDGE
OF THE ROADWAY. IT TRAVELED OVER A PRIVATE DRIVE AND A DITCH. IT STRUCK A
SIGN WITH ITS LEFT-FRONT BUMPER CORNER. IT CONTINUED 48 METERS AND STRUCK
A TREE WITH ITS RIGHT-FRONT CORNER

(Slides 1, 2) On a snowy day, case vehicle (A) was traveling east in the east lane of a two-lane asphalt road, and was approaching a left curve in a rural area. Case vehicle (A) was traveling at an unknown speed and the road was covered with snow and ice. Due to the slippery road conditions, the driver lost control of the vehicle as it began to enter the left curve. (Slide 3) Case vehicle (A) left the south edge of the roadway, crossed a private drive, and entered a deep ditch. (Slide 4) It traveled approximately 27 meters off the road where it struck a curve sign with its left-front corner. The curve sign was located three meters south of the road edge. (Slides 5, 6, 7 and 8) After contacting the sign, case vehicle (A) continued to travel east approximately 48-meters where it struck a tree with its right-front corner. Case vehicle (A) came to rest facing east against the tree.

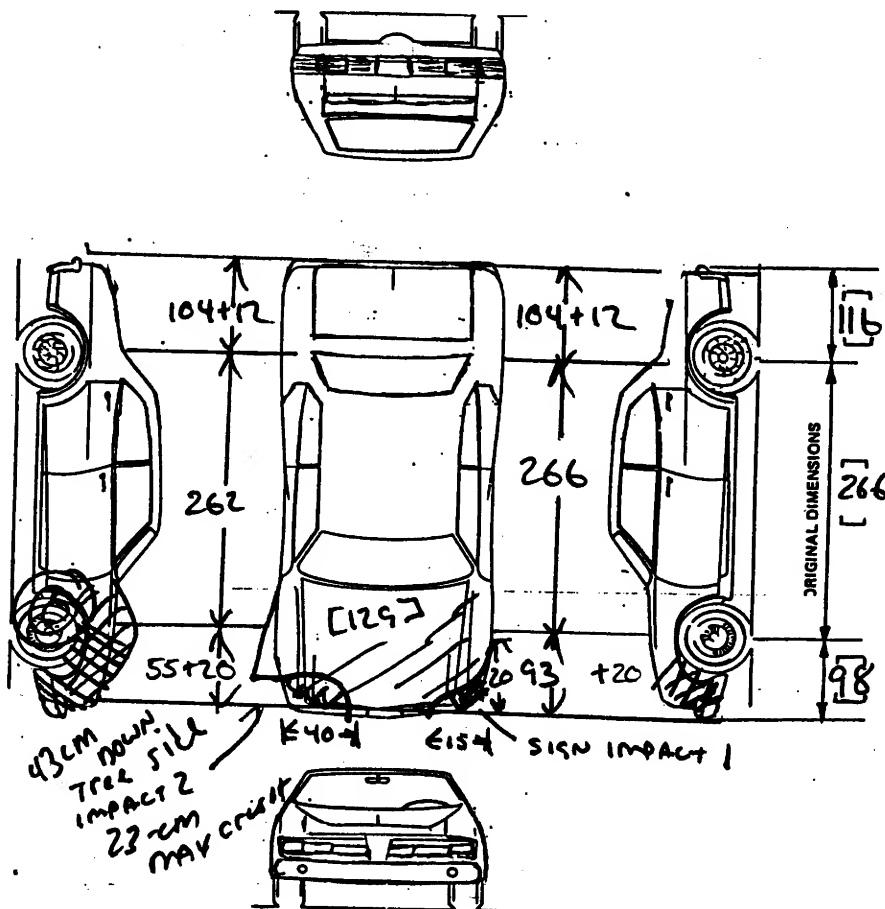
VEHICLE DAMAGE

Direct Damage Length (DDL) 040 cm

(Slides 9, 10) The direct damage to the front of case vehicle (A) from the primary impact with the tree began at the right-front bumper corner and extended 40 cm across the front, resulting in 26 percent vehicle overlap. The maximum crush was 23 cm to the front bumper corner, and extended 43-cm rearward along the right fender. (Slide 11) The direct damage to the left-front corner of case vehicle (A) from the secondary impact with the sign began at the left-front bumper corner and extended 15 cm across the front, resulting in 12-percent vehicle overlap. The maximum crush was 20-cm rearward along the left fender.

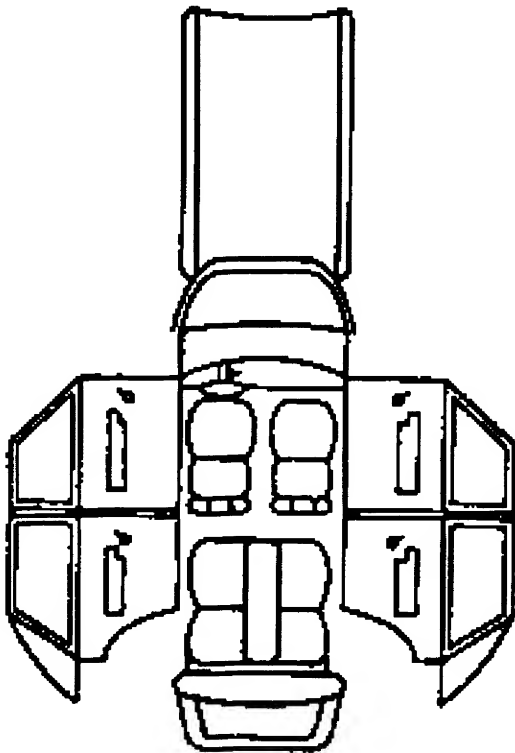
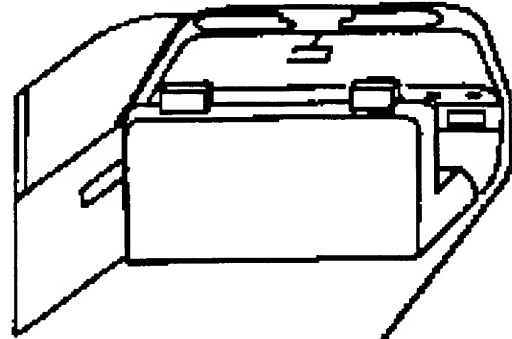
VEHICLE OCCUPANT CONTACT DIAGRAM

Contact	Interior Component Contacted	Occupant No. if Known	Body Region if Known	Supporting Physical Evidence	Confidence Level of Contact Point
A	ARMREST	2	ARM	5-CM SCUFF	2
B	WINDSHIELD HEADR	2	HEAD	4-CM SKIN, HAIR	1
C	SUNVISOR	2	HEAD	19-CM SCUFF OF SKIN	1
D	IP	2	LEG	12-CM SCUFF	1
E	Glove box	2	LEG	16-CM SCUFF	1
F	WINDSHIELD	2	HEAD	CRACKED GLASS	1
G					
H					
I					
J

RF BELT: PRETENSIONER FIRED, BELT
LOCKED TIGHT IN UNWORN POSITION
DR BELT: BLACK WEBBING IMPRINTS
ON D-RING.

compartment area, (slide 29) although scuff marks indicate that the passenger contacted the glove box and the lower panel to the left of the glove box. (Slide 30) There were scuff marks on the right-front portion of the headlining, windshield header, and sunvisor due to passenger contact, but there was no visible damage to these components. (Slide 31) There was no damage to the right-front door panel, but there were scuff marks on the door armrest. There was no other interior damage and no intrusions were noted.

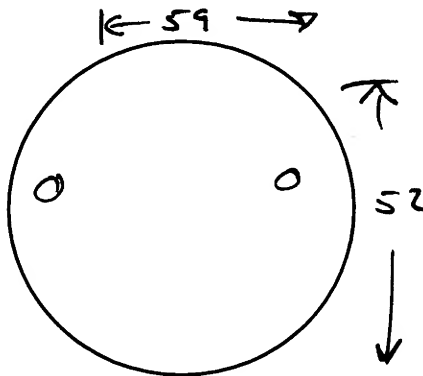
NOTE AND DESCRIBE ANY AIRBAG CONTACT OR
DAMAGE ON DIAGRAM BELOW:

2 DENTS

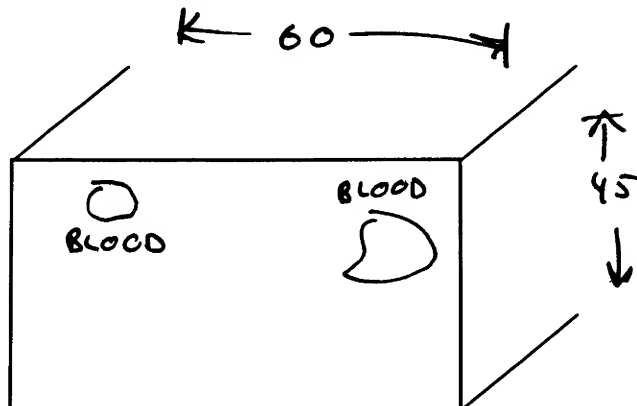
NOTE AND DESCRIBE ANY AIRBAG CONTACT OR
DAMAGE ON DIAGRAM BELOW:

NO DENT

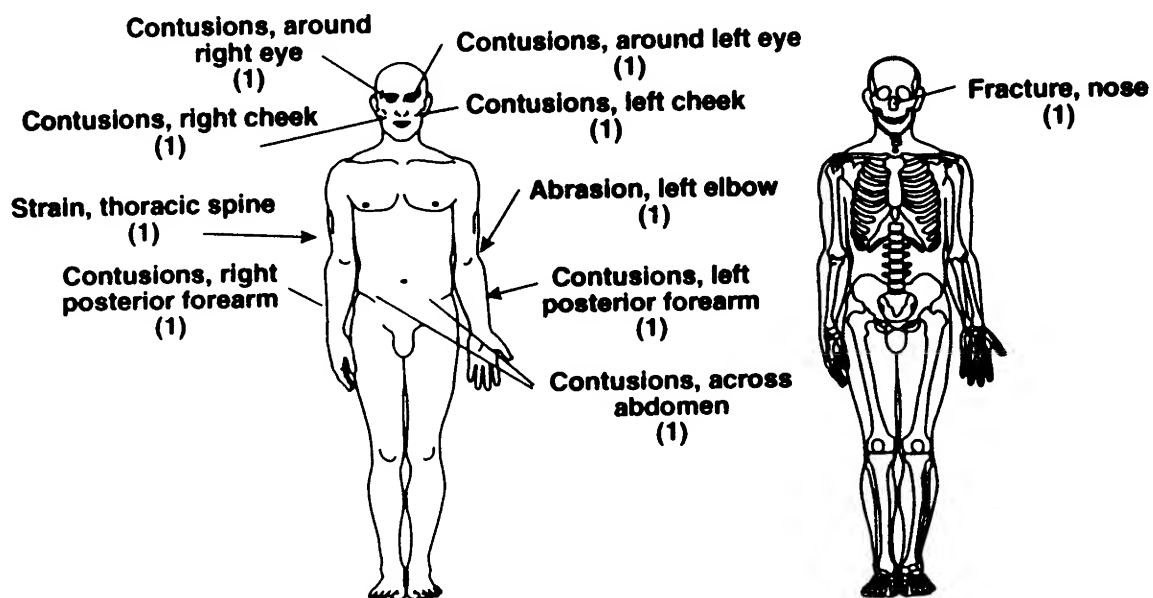
INDICATE LOCATION OF INJURIES.

Injury Description	A.I.S.	Injury Source		
		Definite	Probable	Possible
Contusions, around left eye	1		Airbag	
Contusions, around right eye	1		Airbag	
Contusions, left cheek	1		Airbag	
Contusions, right cheek	1		Airbag	
Fracture, nose	1		Airbag	
Strain, thoracic spine	1		Impact forces	
Contusions, left posterior forearm	1			Steering wheel
Contusions, right posterior forearm	1			Steering wheel
Abrasion, left elbow	1			Side door interior
Contusions, across abdomen	1		Lap belt	
<u>Maximum A.I.S. Level</u>	<u>1</u>			
<u>Injury Severity Score</u>	<u>3</u>

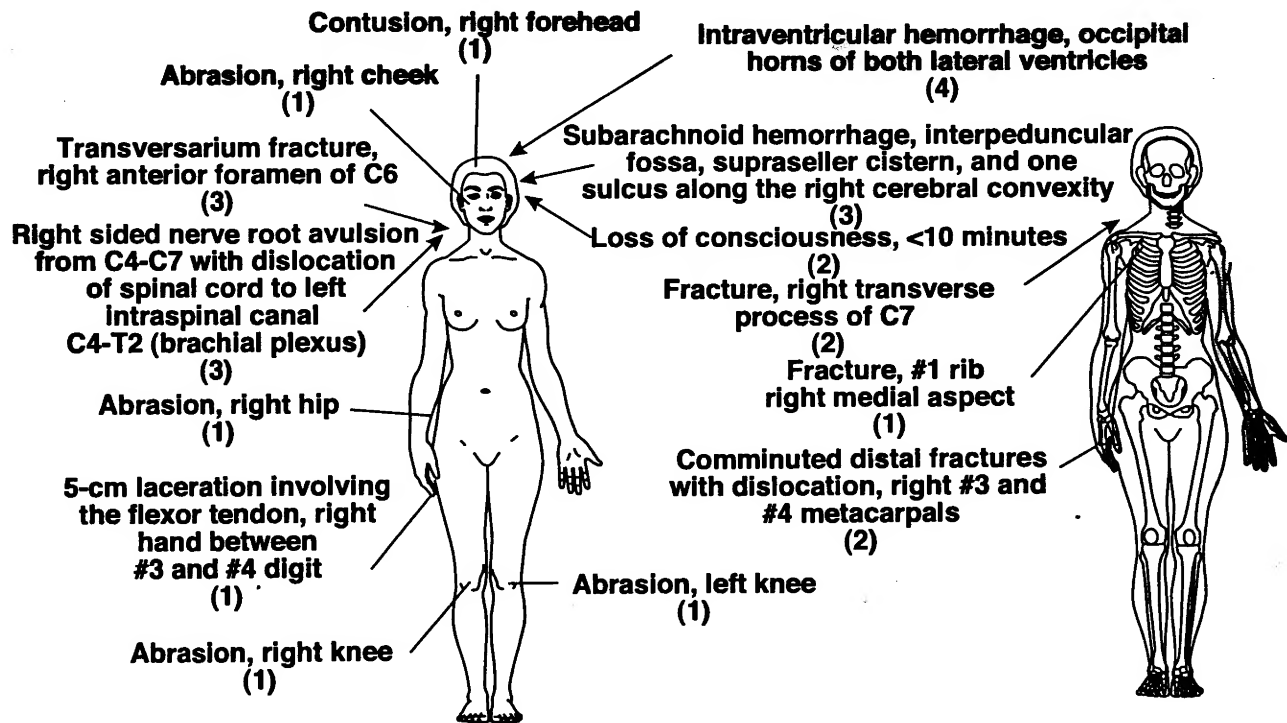
INDICATE LOCATION OF INJURIES.

Injury Description	A.I.S.	Injury Source		
		Definite	Probable	Possible
Intraventricular hemorrhage, occipital horns of both lateral ventricles	4		Header/visor	Airbag
Subarachnoid hemorrhage involving the interpeduncular fossa, suprasellar cistern, and one sulcus along the right cerebral convexity	3		Header/visor	Airbag
Loss of consciousness, less than 10 minutes	2		Header/visor	Airbag
Contusion, right forehead	1		Header/visor	Airbag
Abrasion, right cheek	1		Header/visor	Airbag
Right side nerve root avulsion from C4-C7 with dislocation of spinal cord to left intraspinal canal C4-T2 (brachial plexus)	3		Header/visor	Airbag
Transversarium fracture, right anterior foramen of C6	2		Header/visor/airbag	
Fracture, right transverse process of C7	2		Header/visor/airbag	
Fracture, #1 rib right medial aspect	1			Airbag/vehicle interior
Comminuted distal fractures with dislocation, #3 and #4 metacarpals	2		Airbag/module door

5-cm laceration involving the flexor tendon of right hand between 3rd and 4th digits	1		Airbag/module door	
Abrasion, right hip	1		Side door armrest	
Abrasion, left and right knees	1		Glove compartment	
<u>Maximum A.I.S. Level</u>	<u>4</u>			
<u>Injury Severity Score</u>	<u>21</u>
